Number 18-001622-PR01 (PB-K99-05-en-02)

Product Safety Railings

Designation Shipping name: F50 Horizon Frame-External

Testing of Safety Rails

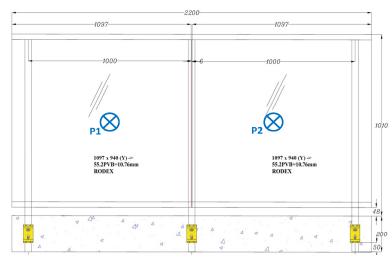
### schematic representation of the specimen and the point of impact

| Pendulum | Drop height in mm | point of impact on<br>the attack side | Remark |
|---|---|---|---|
| 1 | 1200 | P1 | Extraction of the screws by approx. 2 mm from cement camber; no danger from falling parts |
| 2 | 1200 | P2 | Extraction of the screws by approx. 3 mm from cement camber; no danger from falling parts |
