Test Report

Number	19-002756-PR01 (PB-A05-02-en-01)
Owner (Client)	ALUMINCO S.A. Megali Rahi 32011 Inofita Viotias Greece
Product	Glass Railing
Designation	Shipping name: L-Line F85-1B62 TOP MOUNT FIN
Details	Manufacturer ALUMINCO S.A., - Inofita Viotias; Material Laminated safety glass (LSG); Overall dimensions (W x H) 2110 mm x 1212 mm
Special features	
Order	Resistance to wind load
Contents	The test report contains a total of 9 pages and annexes (6 pages).
Note	The test report shall only be published in its unabbreviated form. The "Guidance Sheet for the Use of ift Test Documents" applies.

Resistance to wind load

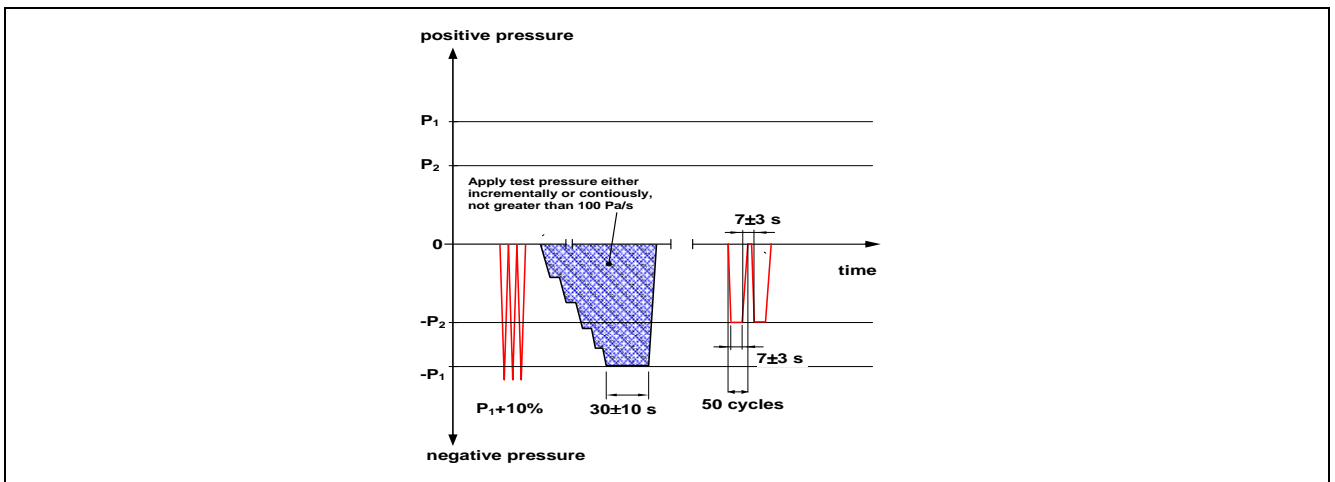
Resistance to wind load was tested in accordance with the standard and conducted in steps at negative pressure up to the test pressure p_1 . The test specimen was exposed to three pressure pulses $Dp_1 + 10\%$. This was followed by determination of the frontal deflection of test specimen for each pressure step when exposed to negative test pressure Dp_1 . Then the test specimen was subjected to 50 cycles at negative pressures of $-Dp_2 = Dp_1 - 50\%$.

Illustration Test sequence for resistance to wind load - Deflection and alternating negative pressures

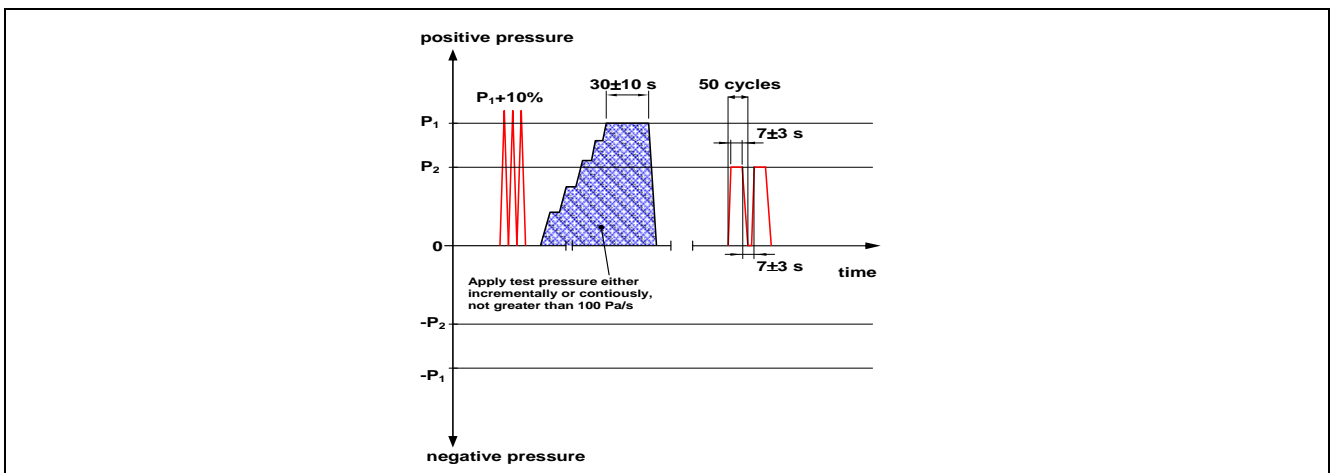
After the resistance to wind load at negative pressure, the resistance to wind load was tested in accordance with the standard and conducted in steps at positive pressure up to the test pressure p_1 . The test specimen was exposed to three pressure pulses $\Delta p_1 + 10\%$. This was followed by determination of the frontal deflection of test specimen for each pressure step when exposed to positive test pressure Δp_1 . Then the test specimen was subjected to 50 cycles at positive pressures of $+\Delta p_2 = \Delta p_1 - 50\%$.

Illustration Test sequence for resistance to wind load - Deflection and alternating positive pressures

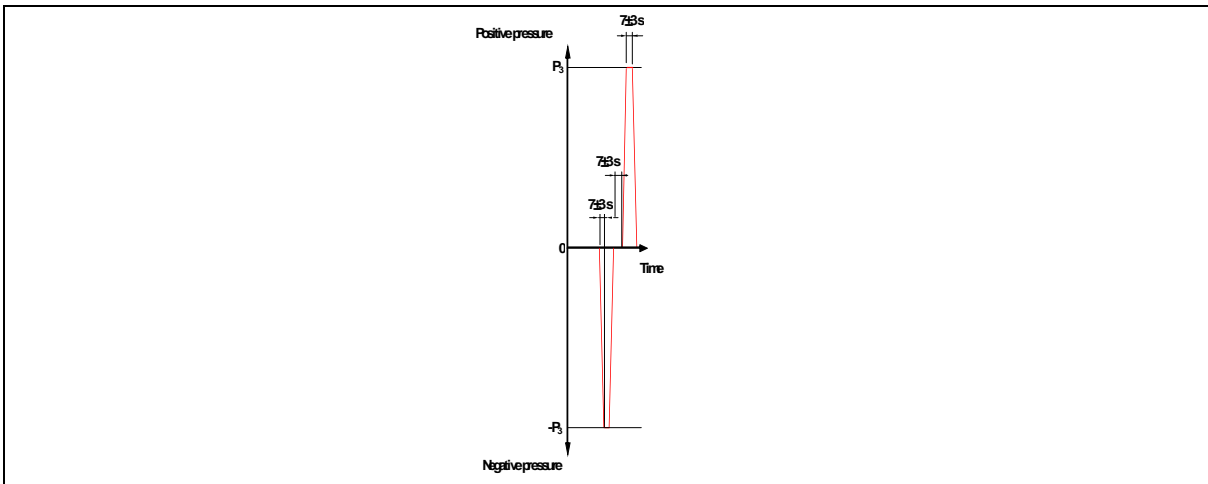
The wind resistance test (safety test) was conducted at negative pressure and positive pressure in accordance with EN 12211 up to test pressure $\Delta p_3 = \Delta p_1 + 50\%$.

Illustration Test sequence for resistance to wind load - safety test

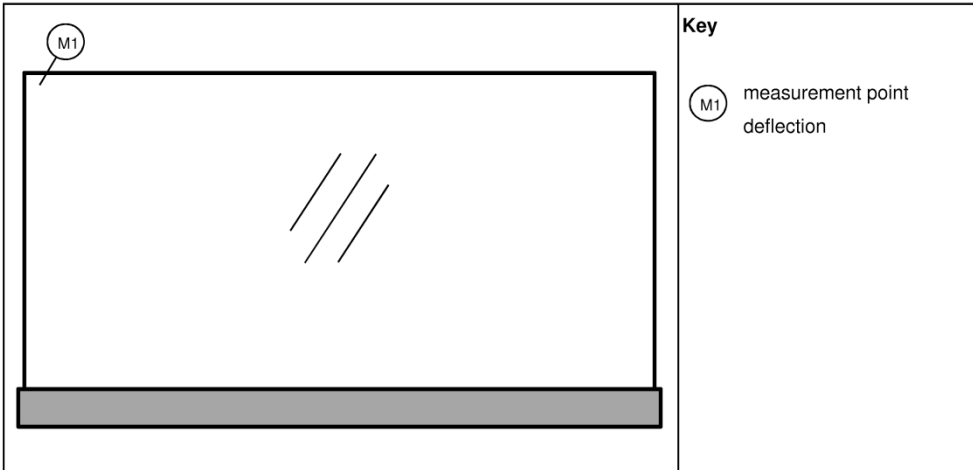
Maximum test pressure: ± 2000 Pa 3 pressure pulses of 2200 Pa

Table: Measured results of frontal deflection in mm at negative / positive wind pressures

Measured results of frontal deflection in mm		Positive wind pressure	Negative wind pressure
	Pa		2000
M1 in mm		55	55

Table: Permanent deformation measured at 0 Pa after 60 seconds

Positive pressure	Negative pressure
Permanent deflection	M1 in mm	2	4

At the test specimen were no malfunctions detected.

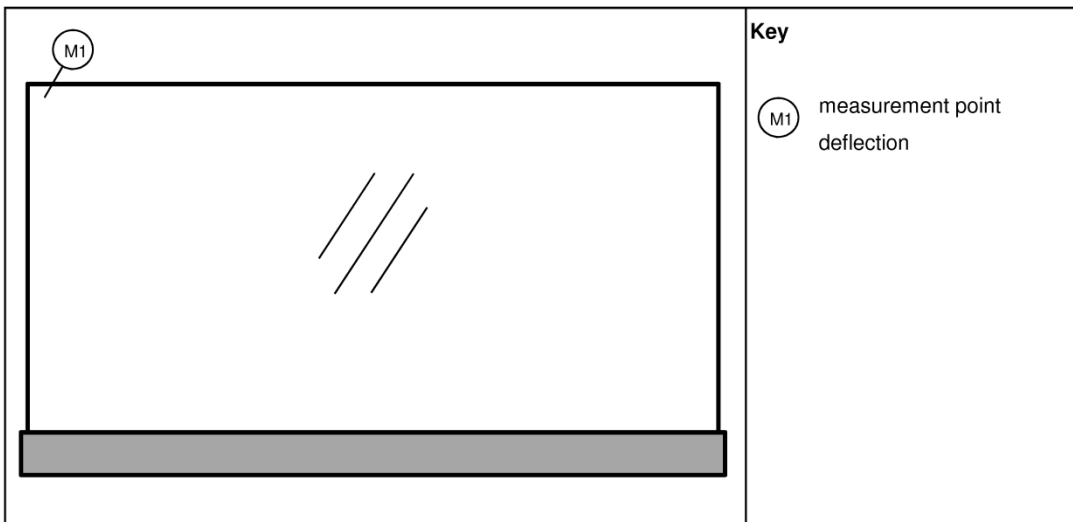
Table: Measured results of frontal deflection in mm at negative / positive wind pressures

Measured results of frontal deflection in mm		Positive wind pressure	Negative wind pressure
	Pa	3000	-3000
	M1 in mm	108	119

Table: Permanent deformation measured at 0 Pa after 60 seconds

Positive pressure	Negative pressure
Permanent deflection	M1 in mm	33	46

Safety test passed at up to + 3000 Pa.

Safety test passed at up to - 3000 Pa.

No damage at test up to + 5000 Pa with permanent deformation 33 mm

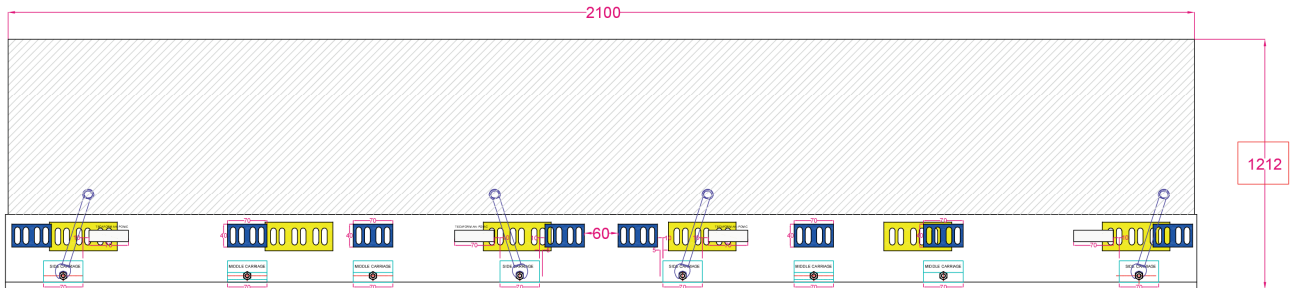
Picture 1 View

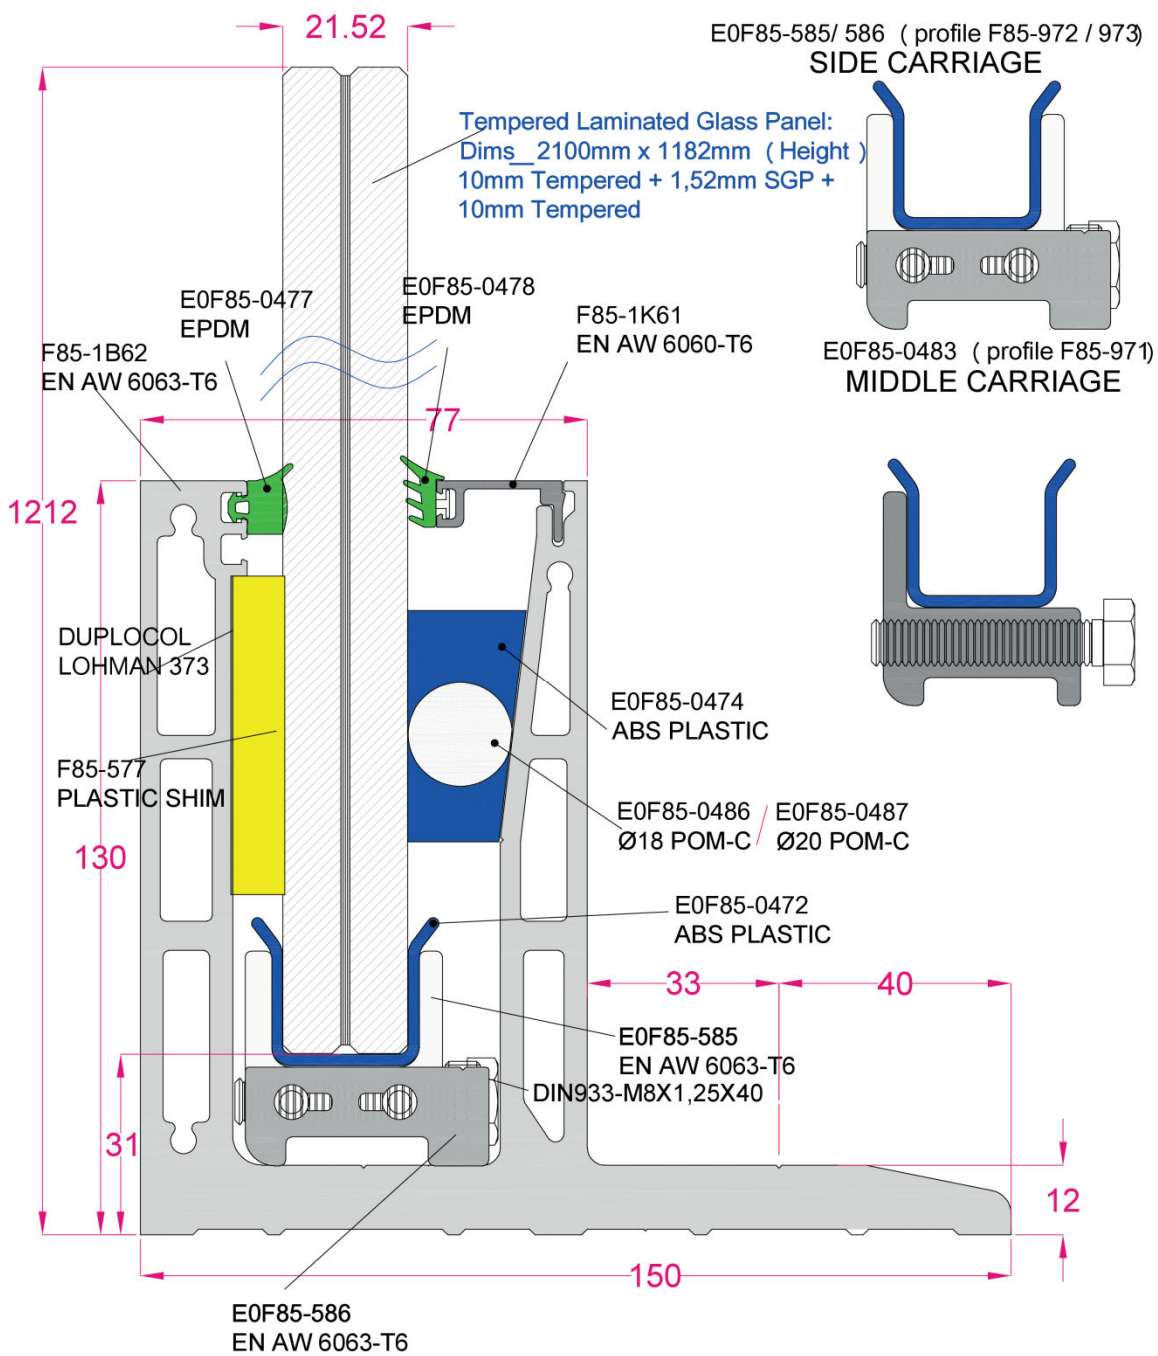
Picture 2 Vertical section

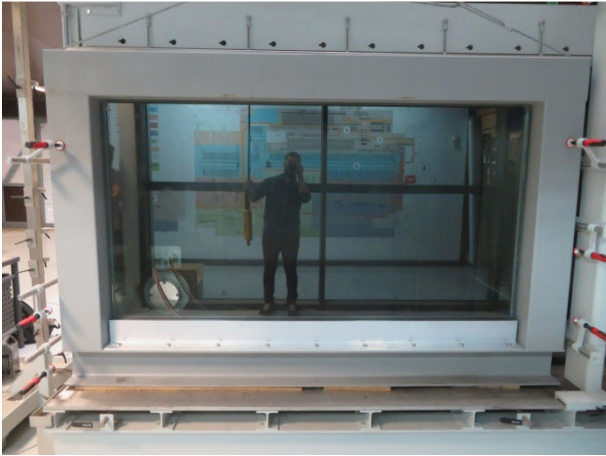
Picture 1 Test specimen

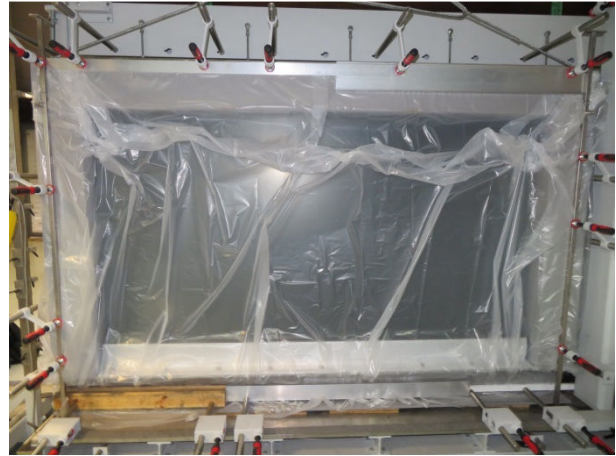
Picture 2 Test specimen with applied film

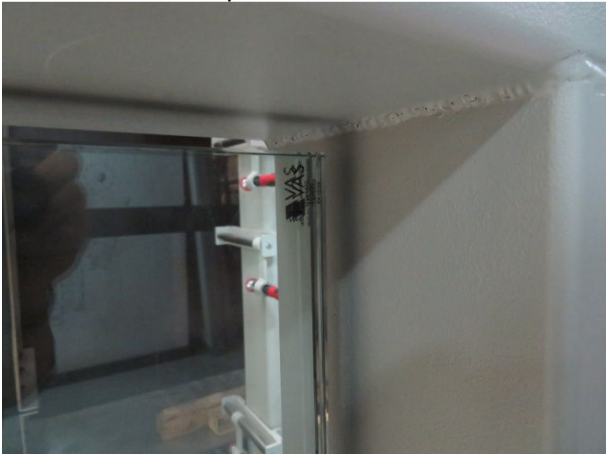
Picture 3 Corner of glazing at top

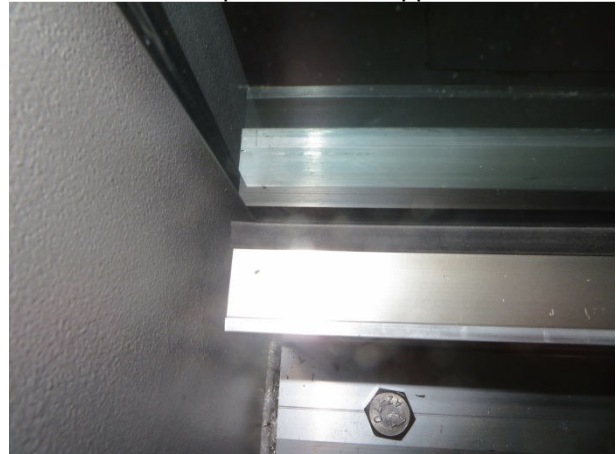
Picture 4 Corner of glazing at bottom

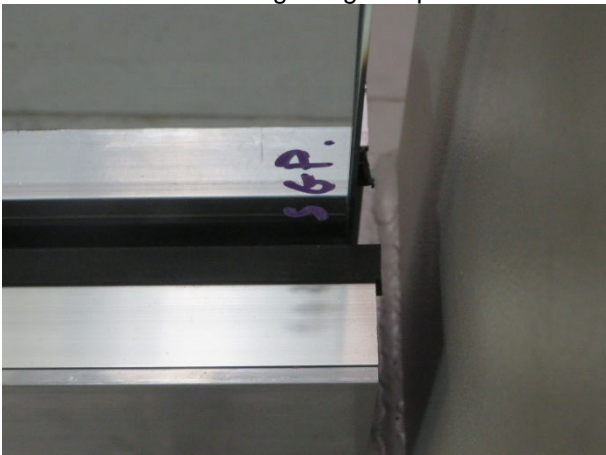
Picture 5 Corner of glazing at bottom

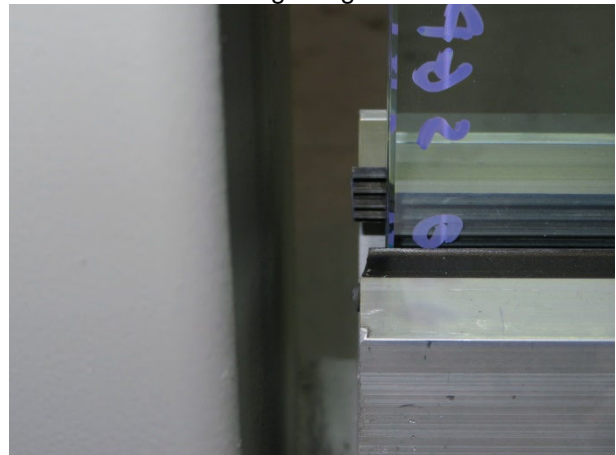
Picture 6 Glazing in Aluminium profile

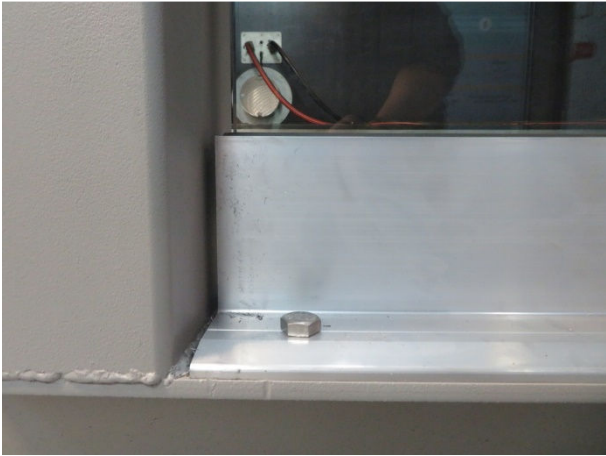
Picture 7 Corner of test specimen

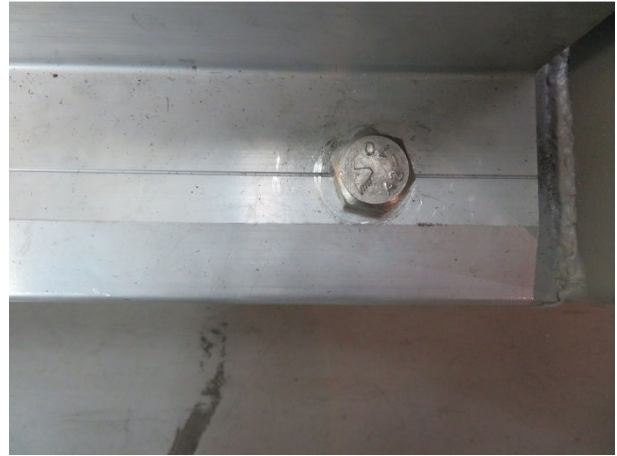
Picture 8 Mounting of test specimen

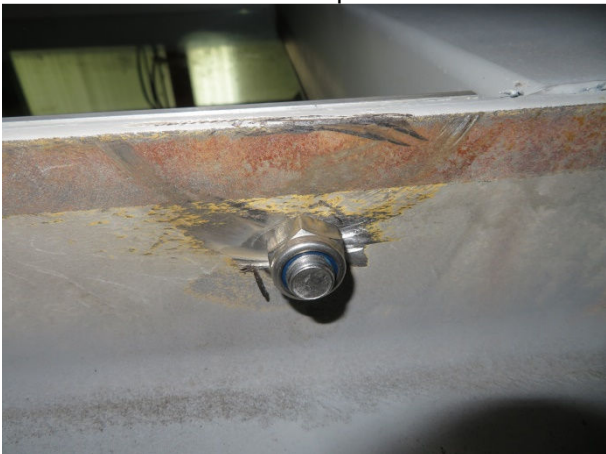
Picture 9 Mounting of test specimen
