# ALUMINCO S.A.

## TEST REPORT

STRUCTURAL PERFORMANCE TESTING ON *CRYSTALLINE L-LINE SIDE MOUNT F85-1B64* GLASS  
BALUSTRADE SYSTEM

I0411.03-119-19-R0

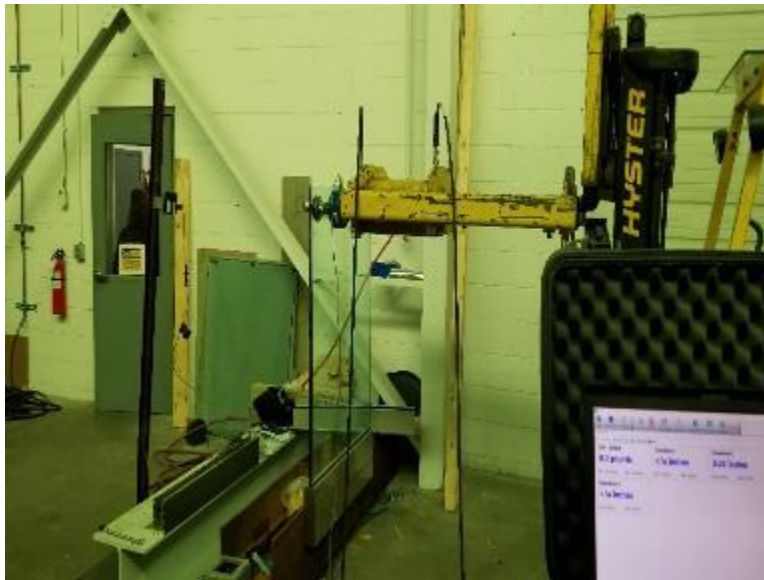
Photo No. 3

Concentrated Load Test at Top Corner of Glass Panel (Applied from Exterior Side)

**Test No. 4 - 01/26/18**

**DESIGN LOAD: 200 lb Concentrated Load at Top Corner of Glass Panel**

**(Applied from Exterior Side)**

LOAD LEVEL	TEST LOAD (lb)	E.T. (min:sec)	MAX DISPLACEMENT (in)
Initial Load	40	00:00	0.00
2.0x Design Load	402	01:05	3.12
Initial Load	40	04:38	0.25
92% Recovery from 2.0 x Design Load			
4.0x Design Load	807	06:50	Achieved Load without Failure

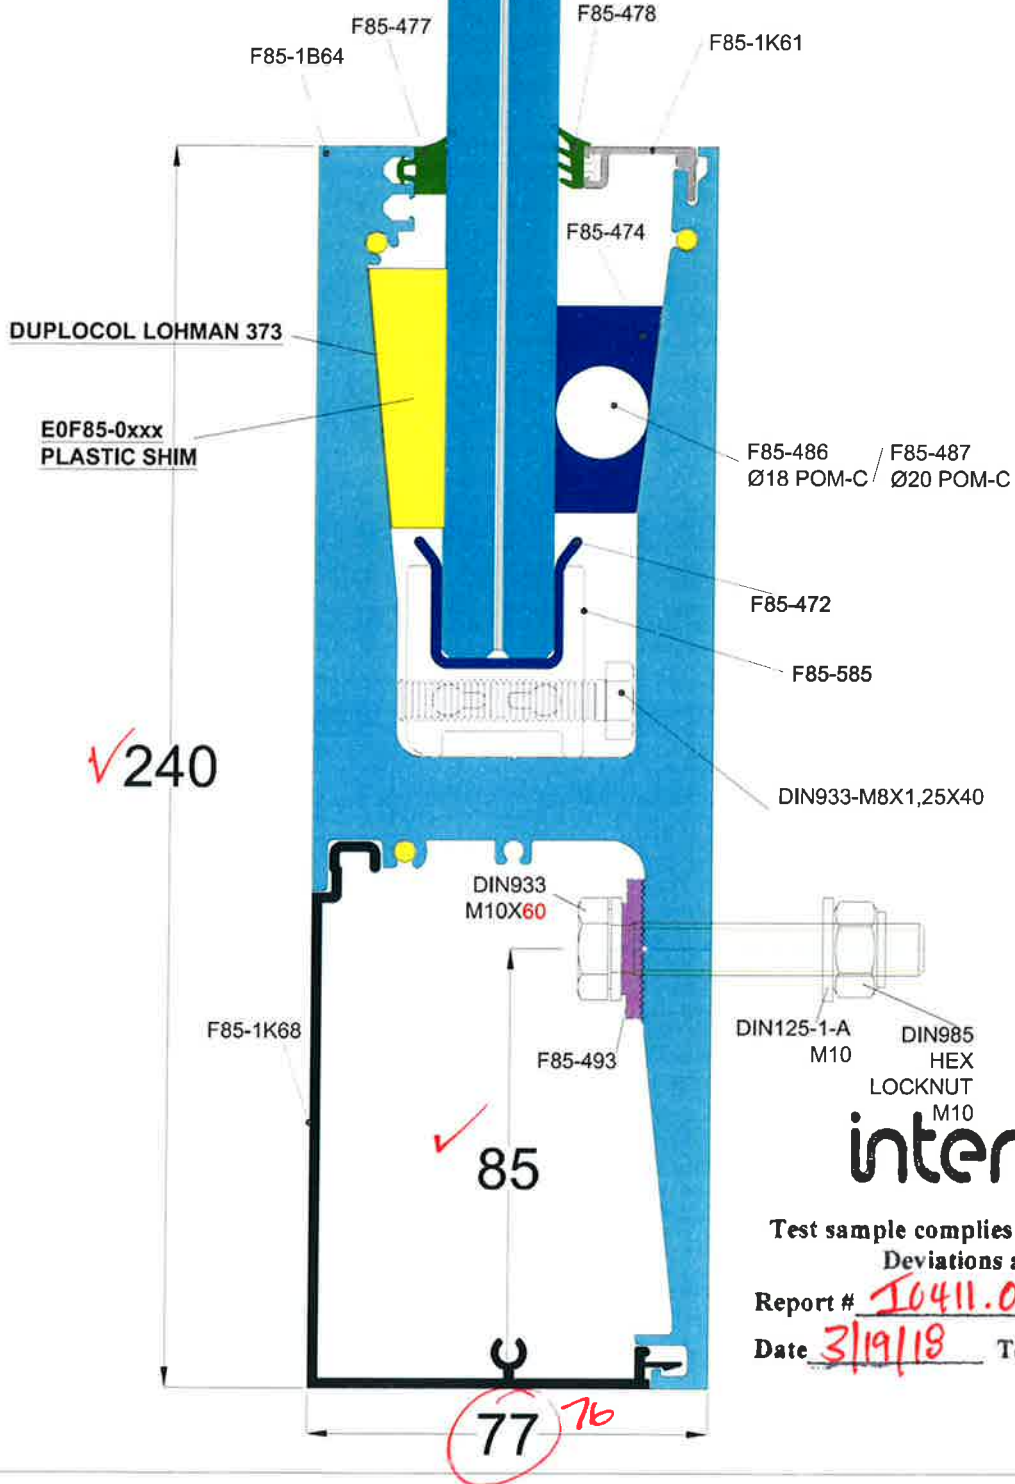
### F85-1B64

The drawings for the *Crystalline L-Line Side Mount F85-1B64* glass balustrade system which follow have been reviewed by Intertek B&C and are representative of the project reported herein. Project construction was verified by Intertek B&C per the drawings included in this report. Any deviations are documented herein or on the drawings.

CRYSTALLINE L-LINE SIDE MOUNTED  
GLASS 10-4PVB-10MM

The *Crystalline L-Line Side Mount F85-1B64* balustrade system consisted of extruded aluminum support shoes with glass panels. The glass panels were 39-1/4 in long with an overall rail height (deck surface to top of top rail) of 52-1/2. Drawings are included in Section 11 to verify the overall dimensions and other pertinent information of the tested product, its components, and any constructed assemblies. Photographs are provided in Section 10.

<b>PRODUCT</b>	<i>Crystalline L-Line Side Mount F85-1B64</i>
<b>TYPE</b>	Aluminum and glass guardrail system
<b>OVERALL DIMENSIONS</b>	39-1/4 in wide by 52-1/2 in high
<b>GLASS PANELS</b>	7/8 in thick laminated glass constructed from two sheets of 3/8 in thick clear tempered glass and an 0.060 in thick interlayer
<b>GLASS CARRIAGE</b>	Two-piece extruded aluminum, secured in place with two 0.31 in O.D. set screws
<b>MOUNTING SHOE</b>	3 in wide by 5-1/4 in high H-shaped aluminum extrusion with a 4-1/4 in long mounting flange

<b>GLASS PANEL TO MOUNTING SHOE</b>	Set onto glass carriages and secured in place with plastic wedge shims located on the interior side of the glass and flat plastic shims on the exterior side of the glass. A kerf-mounted rubber gasket was used on the exterior leg of the mounting shoe and a snap-fit aluminum cover with a kerf mounted rubber fin was used on the interior of the mounting shoe
<b>MOUNTING SHOE TO STEEL FIXTURE</b>	M10 hex head bolt, washer, and nut, located 5 in from each end and spaced 10 in on center
